# Illinois Smart Energy Design Assistance Center

## Level II Audit Report That's Rentertainment

**Published:** 04/01/2010  
**Site Visit:** 01/22/2010  
**Location:** 516 E John Street, Champaign, IL, 61820  
**Contacts:** Jenn Iversen  
(217) 384-0977  
**Auditors:** Anthony Levenda, [aleven2@illinois.edu](mailto:aleven2@illinois.edu)  
Kristine Chalifoux, [kmchalif@illinois.edu](mailto:kmchalif@illinois.edu)  
Anthony Santarelli, [Anthony@illinoisgba.com](mailto:Anthony@illinoisgba.com)

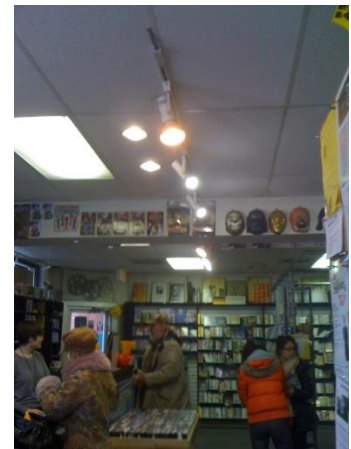
There are several computers, printers, cash registers, and other office equipment in both the office and the check-out area. Lighting is provided by 34W T12 linear fluorescent lamps with magnetic ballasts throughout the space along with CFL spotlights in front of the check-out area.

Some of the T12 fixtures have lamps that were burned out or are temporarily de-lamped. It appears as if the exit signs are LED, but the exit sign lamp at the front of the store was unlit.

- **Replace 34W T12 Fluorescent Lighting** – SEDAC recommends replacing the 34W T12 fluorescent lamps and magnetic ballasts throughout the facility with new 28W T8 fluorescent lamps with high efficiency electronic ballasts. Incentives of \$5/lamp are available from Ameren’s Act on Energy Program.

- **Permanently Delamp Unused Light Fixtures and Lamps** – Currently, some T12 fluorescent fixtures with magnetic ballasts only utilize two or three out of four possible lamps. It is recommended to delamp light fixtures to bring fixtures to ideal lighting levels. For small retail spaces this ranges from 30-50 footcandles for ambient lighting and from 75-100 for accent lighting.<sup>3</sup> Where existing light levels are acceptable, permanently delamping these fixtures will save additional energy. We recommend installing new lamps and ballasts in a few of the existing fixtures (recommendation above) and then removing lamps until the desired light level is obtained. Once the level is accepted, permanently delamp these fixtures by removing the lamp holders. To qualify for this incentive the “unused lamps, lamp holders, and ballasts must be permanently removed from the fixture and disposed of in accordance with local regulations.” Act on Energy’s custom program offers incentives for permanently delamping the fixtures of \$0.05/kWh saved.

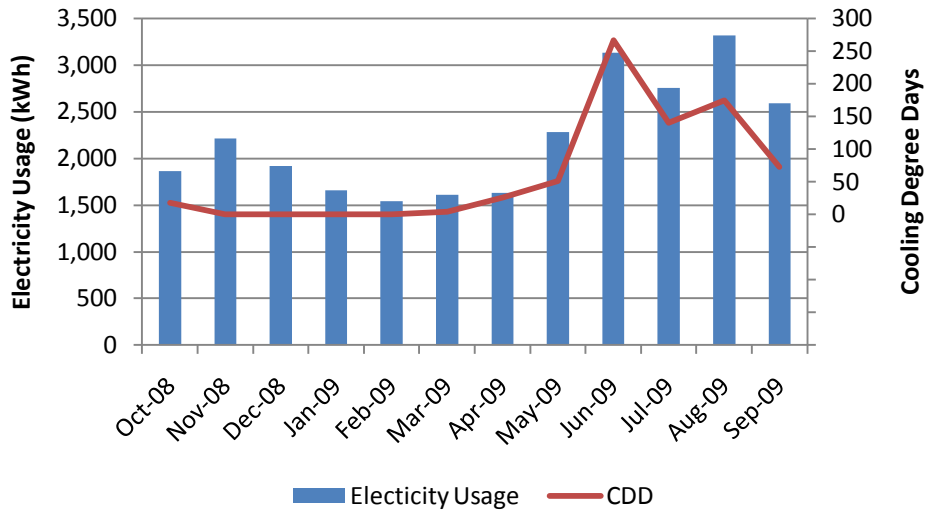
**Figure 1 - Electric Usage vs. Degree Days**

Figure 1 shows the reported monthly electric energy consumption profile for this building compared to cooling degree days. Monthly increases and decreases in electric consumption follow cooling loads for this space in the summer season and show a small increase in the winter, presumably for electric heating. The baseline building electric energy use is approximately 1,500 kWh per month which would account for electricity used for lighting and plug loads.

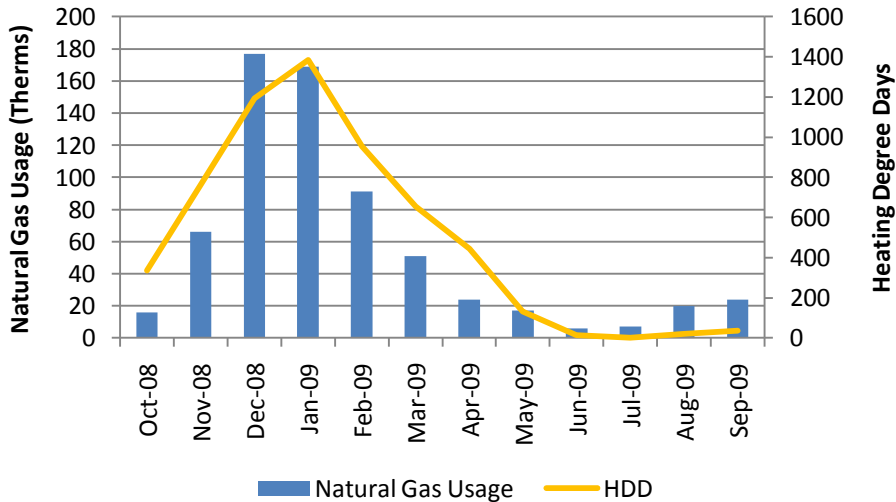
**Figure 2 - Gas Consumption vs. Degree Days**

Figure 2 shows reported monthly natural gas energy consumption profiles compared to heating degree days. The chart shows the baseline energy use for water heating of about 8 therms in the summer and 20 therms in the spring and fall. It is thought that the apartments are not heavily occupied during the summer but when students return, the consumption of hot water increases.

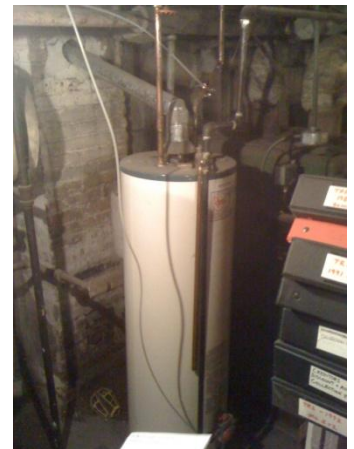
- **Insulation for Water Heater** – The water heater is fairly old. Insulation on hot water pipes will yield modest energy savings and should be implemented. Installing a water heater blanket, which is an insulation jacket that should be installed by a qualified plumber or heating contractor, can reduce water heating costs from 4%-9%.<sup>4</sup>
- **HVAC Duct Screens** – There was a layer of dust on the air supply and return duct screens. We recommend cleaning the ducts as well as cleaning the dust off the screens to improve the efficiency of the HVAC system as well as increase the indoor air quality of the space. Make sure that filters are being changed regularly.
- **Rooftop Unit** – SEDAC recommends having the RTU periodically inspected and tuned to maximize its operating efficiency.
